SERVICE BULLETIN 105 REVISION A MANDATORY

SUBJECT: Retractable Landing Gear Oleo Strut, Weld Inspection and Repair

APPLICATION: Glasair I and II Retractable Landing Gear, Serial Numbers 071 through 302.

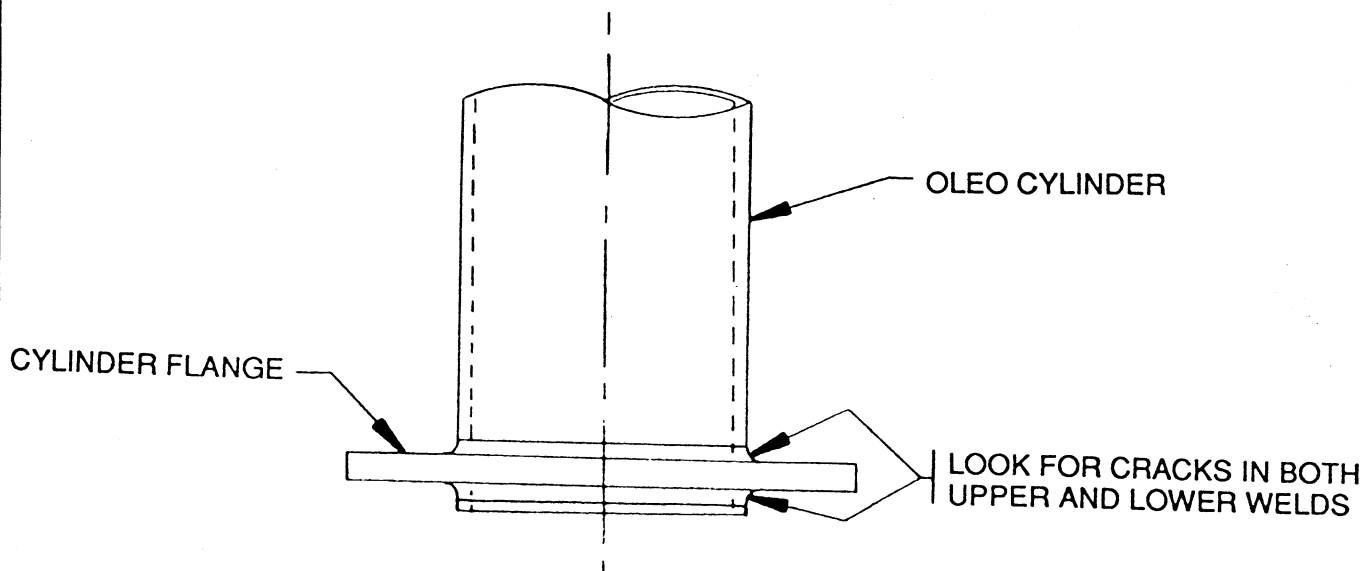
FIGURE (1)

DESCRIPTION: We have received two reports of small cracks found on the upper weld of the chrome oleo cylinder flange on Glasair RG retractable landing gear manufactured by our original subcontractor. X-rays and cross-sectional visual inspections of the cracks have revealed the problem to be a lack of fusion (cold weld) between weld passes. Neither over stress nor fatigue are suspected to be the cause.

Using dye penetrant inspection equipment, which should be available at most local FBOs, inspect both the upper and lower welds that join the fork flange to the oleo cylinder on all three struts, as shown in FIGURE (1). If a crack is found in any of the welds, the cylinder must be removed from the oleo strut and returned to Stoddard-Hamilton Aircraft for repair.

Builders who find cracks in their oleo cylinders must return them to us by November 29, 1991. We will repair the cylinders and return them to you by February 15, 1992. Cylinders to be repaired must be tagged with the builder's name, kit number, and a signed, dated statement saying, "Repair per Service Bulletin 105." The cost for repairing the oleo cylinders is \$125.00 each, plus shipping and packing.
