SERVICE BULLETIN 105 REVISION A MANDATORY

SUBJECT: Retractable Landing Gear Oleo Strut, Weld Inspection and Repair

APPLICATION: Glasair I and II Retractable Landing Gear, Serial Numbers 071 through 302.

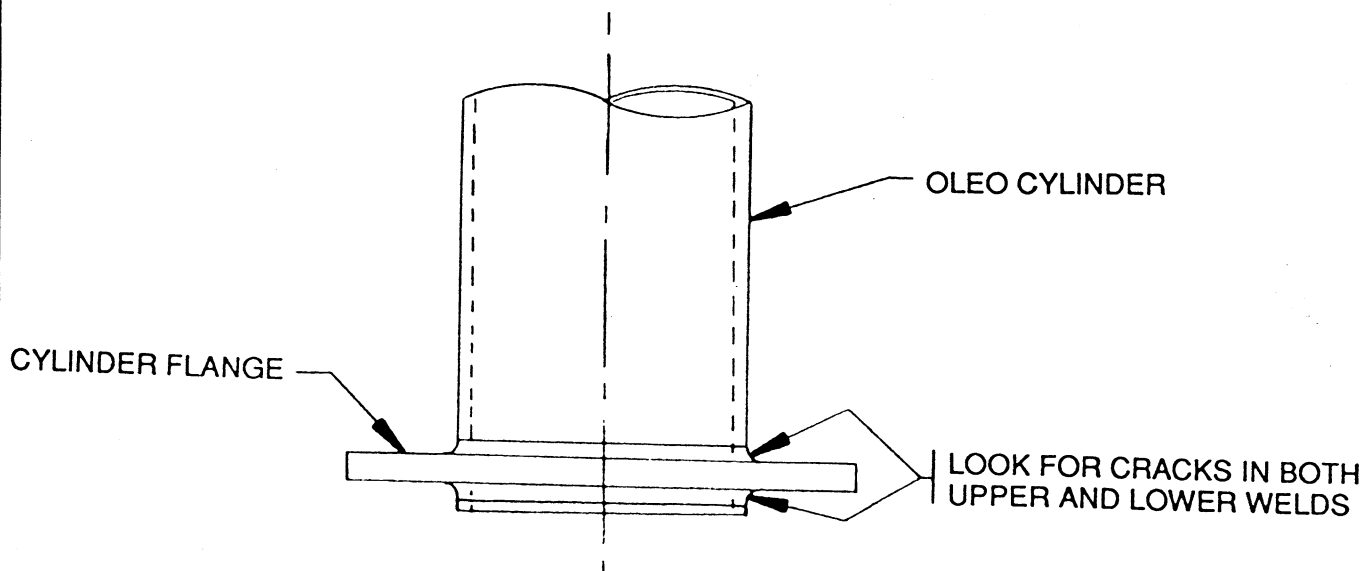
FIGURE (1)

DESCRIPTION: We have received two reports of small cracks found on the upper weld of the chrome oleo cylinder flange on Glasair RG retractable landing gear manufactured by our original subcontractor. X-rays and cross-sectional visual inspections of the cracks have revealed the problem to be a lack of fusion (cold weld) between weld passes. Neither over stress nor fatigue are suspected to be the cause.

The upper and lower oleo cylinder flange welds were each formed by three passes by a semiautomatic TIG welding machine. The subcontractor tells us that lack of fusion was something they had to watch for during the start and stop cycles of the automatic welding machine. Since they were aware of the possible problem at the time of manufacture and inspected closely for it, they suspect that only a few may have escaped without detection. Lack of fusion when starting or stopping the weld process would have affected just a relatively small area of the weld; nevertheless, to minimize any potential for crack propagation or catastrophic failure, any cracks found in these welds must be repaired.

If this service bulletin applies to your landing gear, all three struts must be inspected for cracks in both the upper and the lower welds that secure the fork flange to the chrome oleo cylinder. Inspecting the welds requires that the nose gear fork and the main gear half forks be disassembled from the oleo cylinder flanges. If cracks are found, the affected oleo cylinders must be removed from the landing gear struts and repaired by welding.

Using dye penetrant inspection equipment, which should be available at most local FBOs, inspect both the upper and lower welds that join the fork flange to the oleo cylinder on all three struts, as shown in FIGURE (1). If a crack is found in any of the welds, the cylinder must be removed from the oleo strut and returned to Stoddard-Hamilton Aircraft for repair.
