GLASTAR SERVICE BULLETIN 3

Subject: Wing Attach Holes in Aft Spars

Applicability: GlaStar wing kits shipped from 7/28/95 through 8/11/95 with the following kit serial numbers:

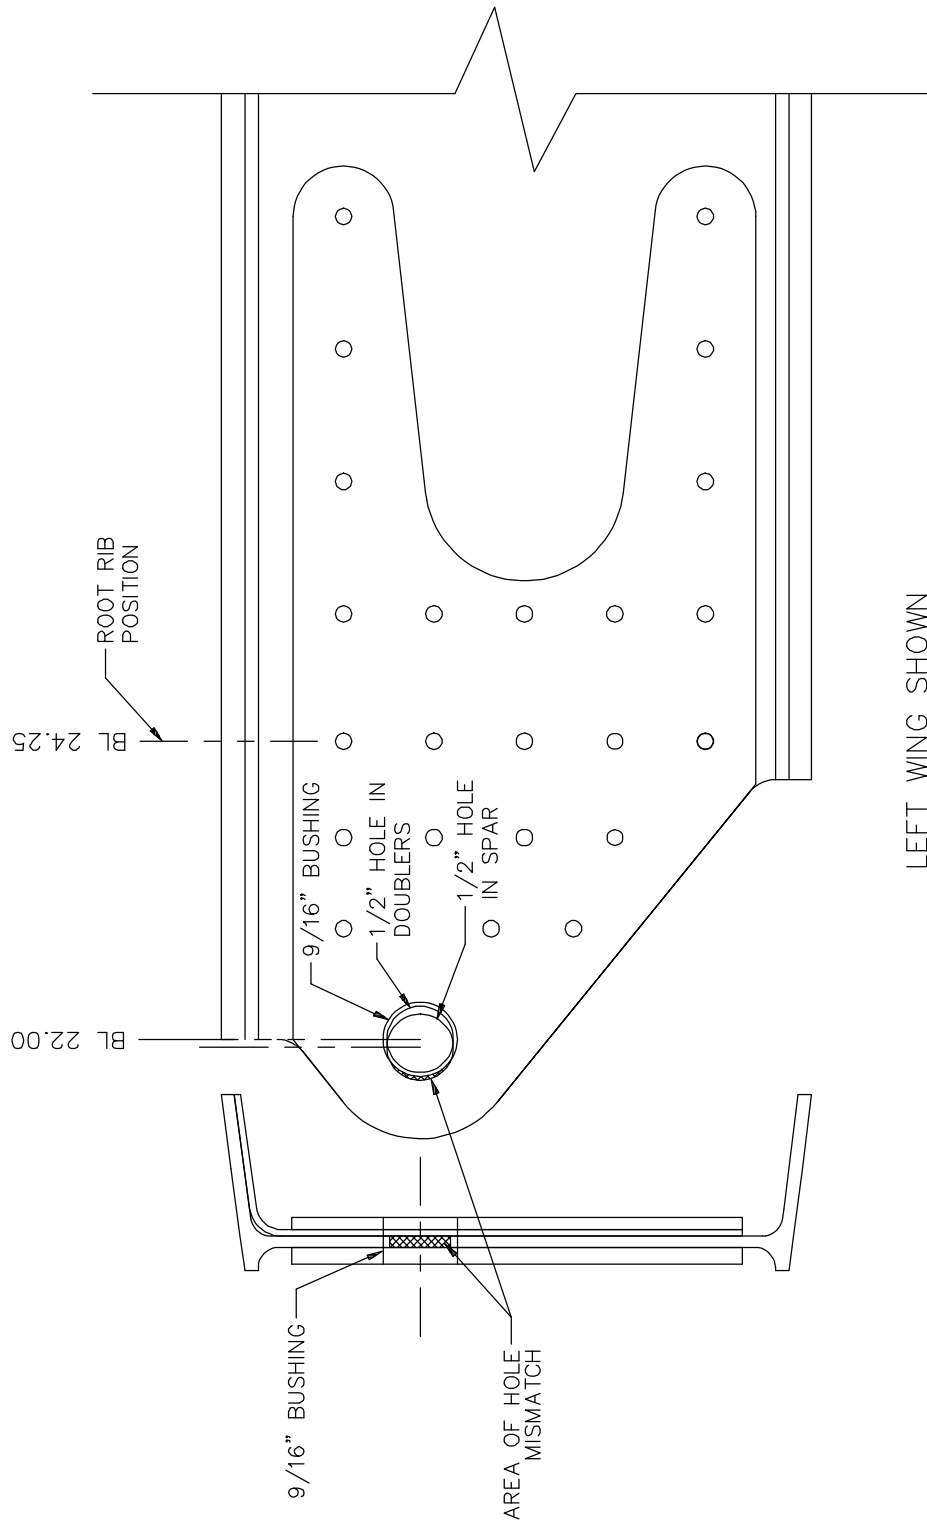
Figure 1: Hole Misalignment in Aft Spar

Discussion: The wing attach holes in the **aft spars** were located about .050" too far inboard in the wing kits referenced above. This condition can easily be remedied by using different procedures to reinforce the aft spar roots than described in Step 7 in "SECTION VI: WING ASSEMBLY" in your *GlaStar Assembly Manual*.

- C) Check the alignment of the wing attach holes in the doublers with the wing attach hole in the spar. The hole in the spar will be offset in the spanwise direction from the holes in the doublers, as shown in Figure 1. Use a small round file to carefully file the **outboard side** of the hole in the **spar** until it almost matches the holes in the doublers. The idea here is to remove just enough of the hole in the spar so that a straight reamer can be run through the hole with minimal resistance. Try not to touch the holes in the doublers with the file, but don't worry if you do; any file marks will be removed when the holes are reamed to final size.

- D) Using the wing attach holes in the **doublers** as a guide, run a 1/2" straight reamer through the assembly to clean up the hole in the spar. Use a drill press for this operation, if you have one; if not, be careful to hold the reamer perpendicular to the spar. Remove the root doublers and deburr all of the holes in all of the parts.
