GLASTAR SERVICE BULLETIN 19

MANDATORY

Subject: Elevator and trim tab hinge edge margin

Applicability: All GlaStar kits shipped prior to the publication of *Assembly Manual* Revision C.

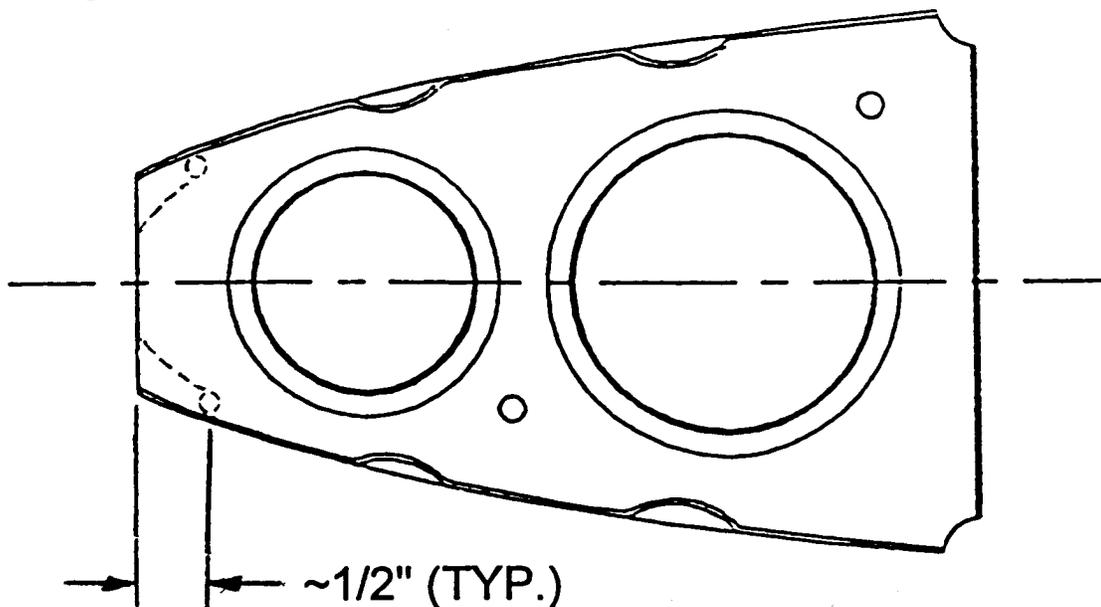
Figure 1: Trimming the Horizontal Stabilizer Nose Ribs

6. In January 1997, the stabilizer nose ribs were shortened by roughly 1/4" to an overall length of about 3-3/4". (The original ribs were P/N 302-00009-01; the new ribs are designated -03.) This will make it easier to pull the stabilizer skins back over the spar/rib structure to their proper position relative to the aft spar and hinges. (This change will take effect when the next run of ribs is produced.)

Recommended Action: If you have not yet drilled or riveted your horizontal stabilizer skins and you received **first-run** nose ribs [P/N 302-0009-01], you can minimize the edge margin problems outlined above by trimming your stabilizer nose ribs. Figure 1 shows how the ribs should be trimmed. Begin by drilling a small hole through the rib web about 1/2" aft of the leading edge immediately above or below the rib flange. A 1/8" or #30 bit will be just about right. Then use a pair of snips cut away the web as shown by the dashed line, leaving only the flange itself. Sand or file the cut edges smooth.
