GLASTAR SERVICE BULLETIN 22

Subject: AN470A3-4.5 soft rivets

Applicability: GlaStar tail kits shipped between 1/1/97 and 3/1/97, inclusive (kit serial numbers 5096, 5319, 5367, 5368, 5370–5374, 5376, 5377, 5380–5384, 5386–5392, 5394–5414, 5416–5426, and three other tail kits for which kit serial numbers were not issued)

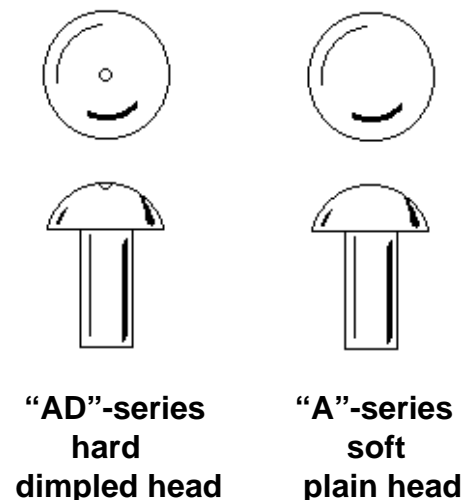
Figure 1

Required Action: First, inspect your supply of AN470AD3-4.5 rivets and **remove** all the soft, "A"-series rivets. They can be distinguished from the "AD"-series rivets by the heads. As shown in Figure 1, the standard, "AD"-series rivets have a small dimple in the center of the head, while the soft, "A"-series rivets have plain heads.

Second, inspect any completed work on your GlaStar tail surfaces to see if any soft, "A"-series rivets were used. If you discover any soft rivets, **you must drill them out and replace them** with proper AN470AD3-4.5 rivets. If necessary, refer to "SECTION II: TOOLS AND TECHNIQUES" in the *GlaStar Assembly Manual* to refresh your memory on the proper procedure for replacing soft rivets.
