GLASTAR SERVICE BULLETIN 25

Subject: Variations in wing angle of incidence

Applicability: GlaStar fuselage cage assemblies S/N 001—303 (Serial numbers for cages S/N 001—293 are stamped above the right wing pivot mounting lug; on cages S/N 294 or later, they are stamped on the outboard side of the right taildragger main gear socket. The serial number is also recorded on the Steel Parts Kit Contents List.)

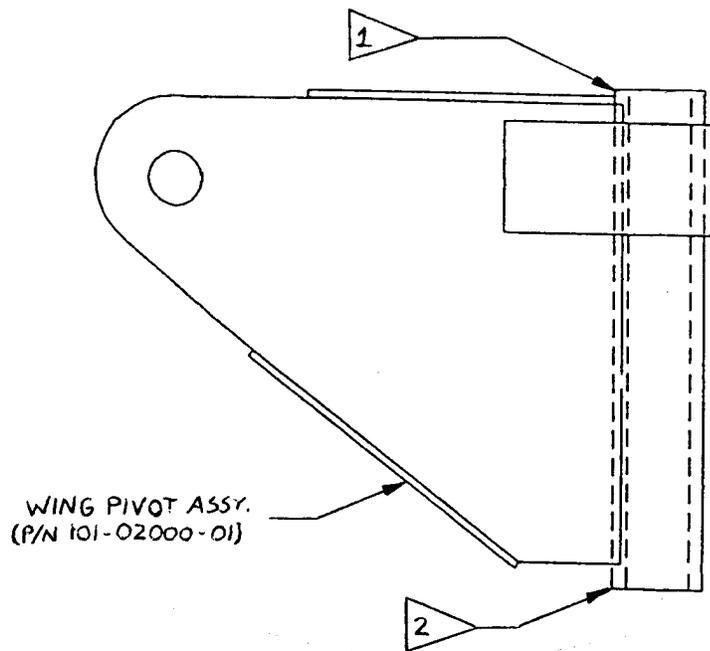
Several builders have taken steps to adjust the incidence angle of the wing on one or both sides by grinding down the wing pivot assemblies (P/N 101-02000-01) at the locations indicated by Flags 1 and 2 in Figure 1 (on the following page) and inserting washers either above or below the pivot, thereby adjusting the trailing edge of the wing up or down to bring the two sides into congruence. This modification has the desired aerodynamic effect, but it can give rise to serious structural concerns. The pivot bolt is designed to handle **shear loads only, not bending loads**. Because washers cannot carry shear loads, insertion of washers between the pivot assembly and the cage lugs has the effect of putting the pivot bolt in bending. For this reason, **a maximum of one standard, .063"-thick AN960 steel washer is permissible between the top of the pivot and the upper cage lug (at Flag 1) or a maximum of two such washers is permissible between the bottom of the pivot and the lower cage lug (at Flag 2).**

- B)** If you measure a difference in incidence angle from left to right of **more than 1.0°**, we **recommend** that you first try to relieve the problem by modifying one or both pivot assemblies and inserting a washer or washers up to the permissible number specified on Page 1. Modify the pivot(s) by grinding away the tube portion of the assembly in the location(s) indicated by Flag 1 and/or Flag 2 in Figure 1. As the figure shows, there is more excess tube material at the bottom (Flag 2) than at the top (Flag 1), so we recommend grinding the bottom first and only grinding the top if necessary to install the maximum number of permissible washers.

Adding a single standard, .063"-thick AN960 washer above or below the pivot will change the angle of the wing by approximately **.15°**, and we expect that this will be sufficient to bring the vast majority of cages within the 1.0° tolerance range.
