# GLASTAR SERVICE BULLETIN 37

## MANDATORY

**Subject:** Aileron cable interference

**Applicability:** All GlaStar kits shipped prior to the publication of *GlaStar Assembly Manual* Revision D

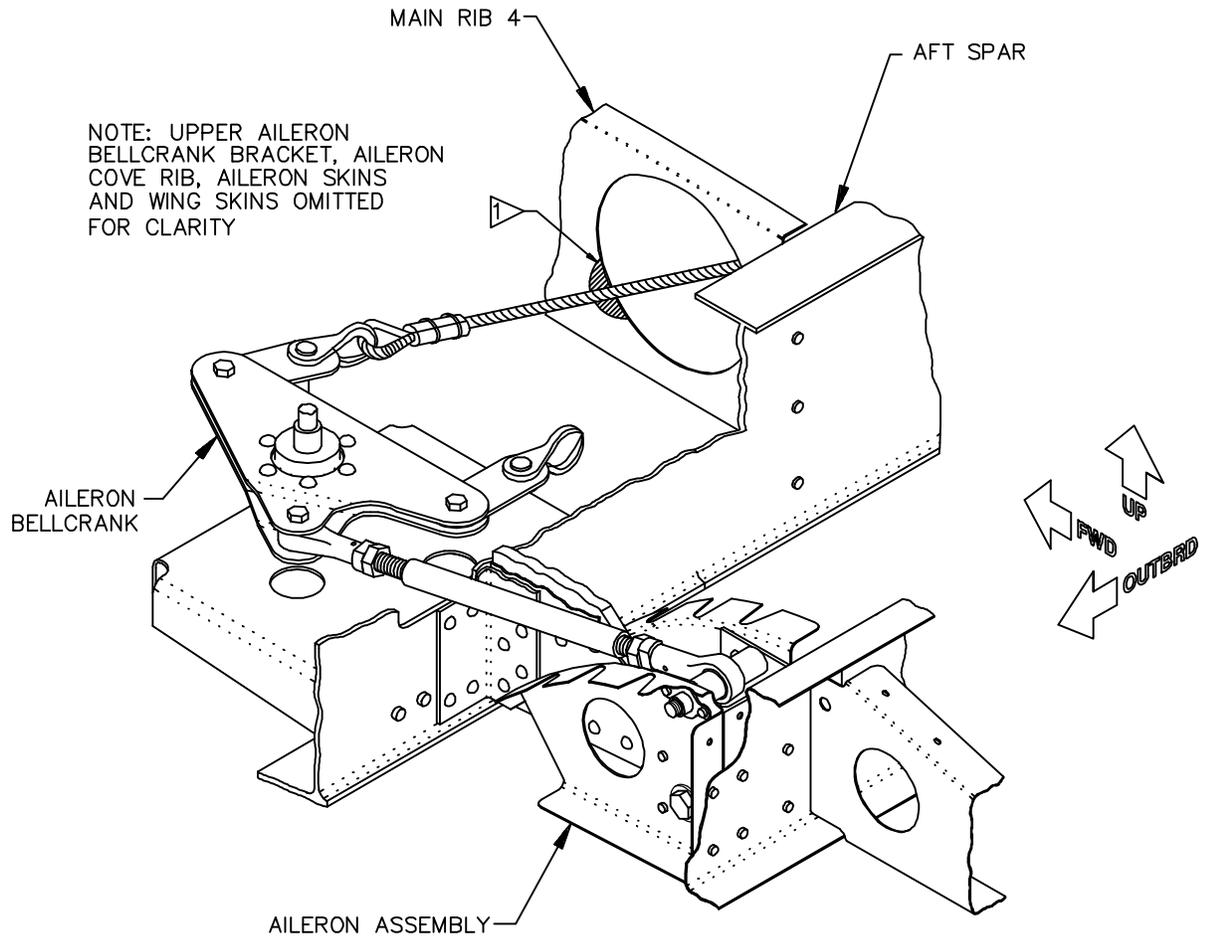
**Discussion:** It has come to our attention that interference may exist between the crimped NicoPress sleeve at the outboard end of each aileron crossover cable and the forward edge of the aftmost lightening hole in Main Rib 4. Because this interference is slight and is likely to occur only at the extreme up aileron position, it is easy to miss on initial rigging and even on later inspection of the completed installation. However, any interference between control cables and the airframe is unacceptable and must be corrected.

Remove the inspection hole covers under the aileron bellcranks on both wings. While an assistant moves the stick from one extreme of aileron travel to the other, use a flashlight to inspect for interference between Main Rib 4 and the cable coming off the **forward** arm of the bellcrank. (See Flag 1 in Figure 1.) There should be no contact whatsoever at any point in the aileron travel between the rib and the cable or the NicoPress sleeve. If no interference is found, no further action is required.

Figure 1: Possible Aileron Cable Interference

If interference is discovered, the solution is simply to relieve the rib web at the forward edge of the aftmost lightening hole to eliminate the interference. As indicated by the shaded area in Figure 1, use a file or a grinder to cut away a crescent-shaped piece of the rib web as necessary to allow complete clearance for the cable and NicoPress sleeve. Smooth the cut edges.
