GLASTAR SERVICE BULLETIN 38

MANDATORY

Subject: AN470A4-9 soft rivets

Applicability: Kits #5402, 5408, 5414, 5464, 5515, 5538, 5539, 5568, 5586, 5602, 5603, 5604 and 5610

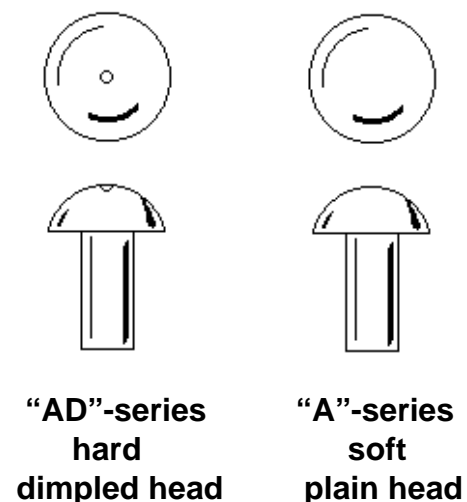
Figure 1

Discussion: It has come to our attention that the supply of AN470AD4-9 universal-head rivets shipped with GlaStar wing kits between February 2 and February 24, 1998, was contaminated with a small quantity of AN470A4-9 rivets. These "A"-series rivets, which were inadvertently mixed in with the "AD"-series rivets by our vendor, are made of a much softer aluminum alloy than the "AD"-series specified for the GlaStar and therefore have insufficient strength. **They should not be used anywhere in GlaStar construction.**

Required Action: First, inspect your supply of AN470AD4-9 rivets and remove all the soft, "A"-series rivets. They can be distinguished from the "AD"-series rivets by the heads. As shown in Figure 1, the standard, "AD"-series rivets have a small dimple in the center of the head, while the soft, "A"-series rivets have plain heads.

Second, inspect any completed work on your GlaStar wings to see if any soft, "A"-series rivets were used. In all likelihood, you would have discovered the "A"-series rivets while riveting because they are so much softer than "AD"-series rivets that they drive with a distinctly different, softer feel. If you discover any soft rivets, **you must drill them out and replace them** with proper AN470AD4-9 rivets. If necessary, refer to "SECTION II: TOOLS AND TECHNIQUES" in the *GlaStar Assembly Manual* to refresh your memory on the proper procedure for replacing defective rivets.
