GLASTAR SERVICE BULLETIN 39

Subject: Counterweight attachment to elevator counterweight ribs

Applicability: All GlaStar fuselage kits shipped prior to 12/8/98

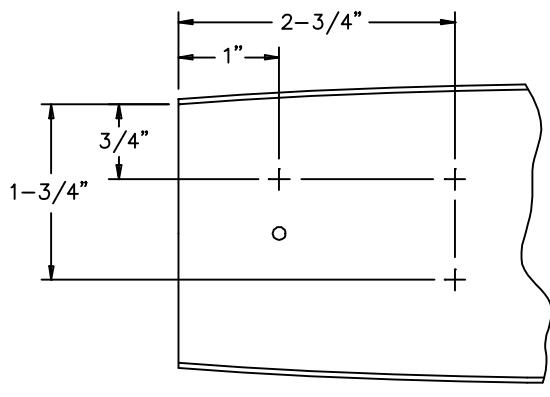
Figure 1: Third Hole Location for Ribs
Already Drilled

Discussion: We have received a report from a GlaStar owner of cracking in the elevator counterweight rib. The cracks, which measured approximately 3/4" in length, emanated from the holes for the counterweight attach screws. The subject aircraft had approximately 90 hours in service at the time of the discovery.

The cause of the observed cracking can likely be traced to the fact that the counterweight lead is attached with only two screws. These screws define a single axis about which the lead "rocks" when subjected to vibration in the course of normal operations. This fatigues the metal around the screw holes, allowing cracks to propagate. The solution is to add a third attach screw to prevent the rocking action of the counterweight.

Figure 1 shows the recommended location for installing a third attach screw through the counterweight stack for ribs that have already been drilled per the *Assembly Manual*. Figure 2 shows new recommended locations for all three holes for ribs that have not yet been drilled. Drill the appropriate hole(s) through the rib and the lead stack per the instructions for Step 39 in "SECTION V: ELEVATOR ASSEMBLY" and Step 174 in "SECTION X: FINAL ASSEMBLY."

Secure the counterweight stack with AN509-10R24 flush-head machine screws, AN970-3 large steel washers and AN364-1032A nylon self-locking nuts. Two of each of these pieces of hardware are supplied with this bulletin.

Note In drilling the third hole through an already completed counterweight stack, you are removing some mass from the counterweight. However, the difference between this lost mass and the mass added by the additional screw, washer and nut is entirely negligible. There is no need to rebalance the elevator after this procedure has been accomplished.
