GLASTAR SERVICE BULLETIN 48

Subject: Elevator Bellcrank Clearance Inspection and Aileron Inspection Provisions.

Applicability: All GlaStar kits

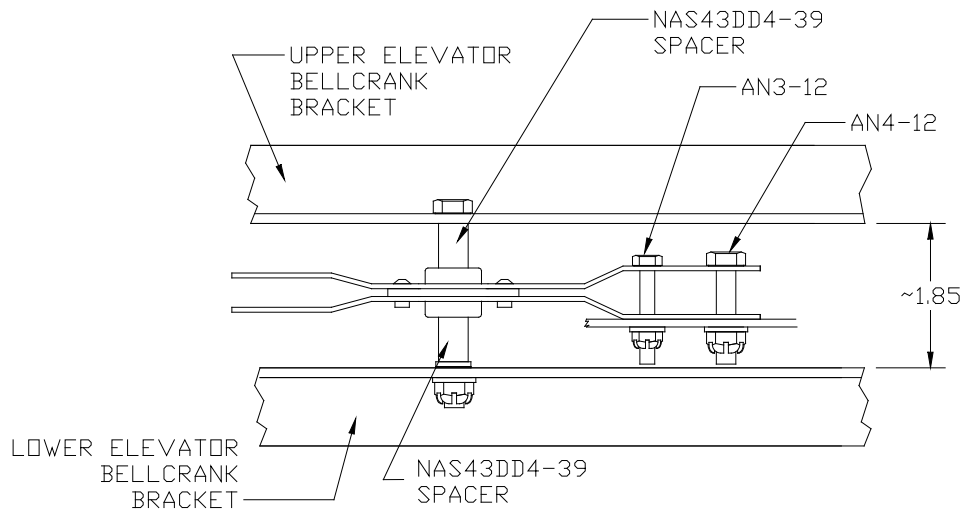
As the elevator bellcrank moves through its range of motion for controlling the elevator, adequate clearance should be maintained at all times between all moving parts to avoid potential interference and binding of the control system. When the builder first installs the upper and lower bellcrank brackets in the fuselage as prescribed in Figure 85 of Section VIII, the Assembly Manual does not give a controlling dimension, but rather just says to use the “clamped up assembly”. If the brackets are installed properly and parallel to each other, the distance between the upper and lower brackets should be approximately 1.85 inches as shown in Figure 1 below. Since the two NAS43DD4 spacers are of equal length, the bellcrank assembly is centered between the two brackets. But when the control cable, elevator stop and elevator pushrod hardware is installed, the clearance at the bottom of the two bolts shown in Figure 1 is marginal or inadequate.

Figure 1. Elevator Bellcrank Assembly and Installation per the Assembly Manual.

For those airplanes that are already flying or which have all the control rigging done and the tail section closed out, the primary importance is an inspection of the system as you have installed it. Remove the lower fuselage inspection cover and with a mirror and adequate lighting, move the elevator controls through its range of motion and measure the clearances between the upper and lower ends of the three bolts on the bellcrank. **The minimum recommended clearance on the lower edge of the bolt should be approximately 3/16 inch.** If you find your clearance is less than the minimum, you can gain 1/8 inch by switching the bolts over to an AN4-11 and an AN3-11 from the AN4-12 and AN3-12 as specified in the assembly manual. If you need additional clearance, then use the NAS43DD4 spacers specified in Figure 2. **Before you attempt to replace any hardware, the cable tension will have to be released on the elevator control cables.**

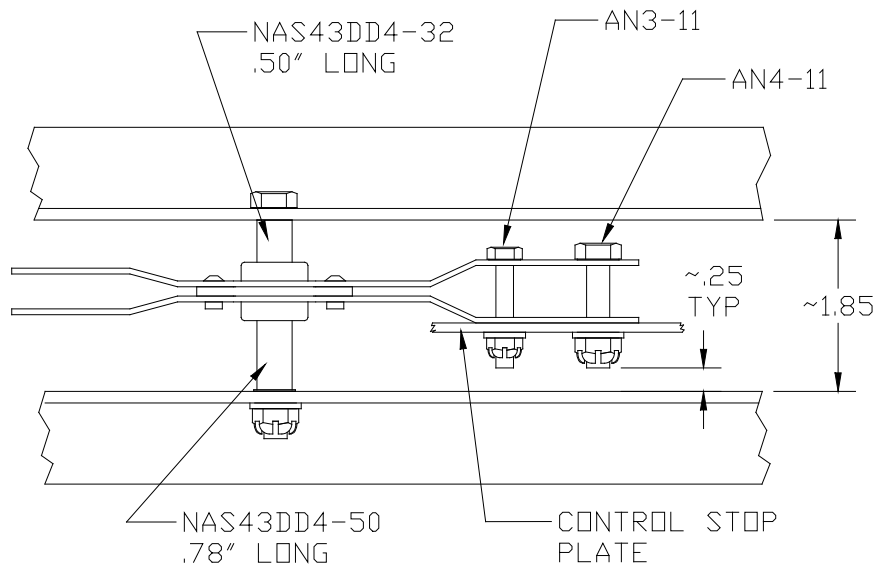
Figure 2. Modified Elevator Bellcrank Installation for Improved Clearances

Figure 2 below gives a more optimum arrangement when installing the bellcrank assembly between the upper and lower brackets. By using unequal NAS43DD4 spacer lengths, the bellcrank assembly can be shifted up providing more clearance to the bottom of the bolts. By going to AN3-11 and AN4-11 bolts, additional clearance can be gained and still have adequate grip length for the bolts through the bellcrank assembly and the control stop. The builder should aim for .25 inches of clearance between the bolts and the bellcrank brackets. We have observed that the elevator pushrod attach bolts on the bellcrank assembly tend to deflect marginally up under a positive or tail down load (approximately .05”). Therefore, slightly more clearance should be provided between the head of the bolt and the upper bracket.

The NAS43DD4 Bolt Spacers can be made from 6061-T6 or 2024-T4 aluminum with an outside diameter of .38 - .50 inch. The bare material should be primed for corrosion protection. A Service Bulletin Kit **P/N GSSB48KIT-1** is available through Glasair Aviation USA, LLC. This kit includes two new NAS43DD4 bolt spacers and the AN3-11 and AN4-11 bolts.

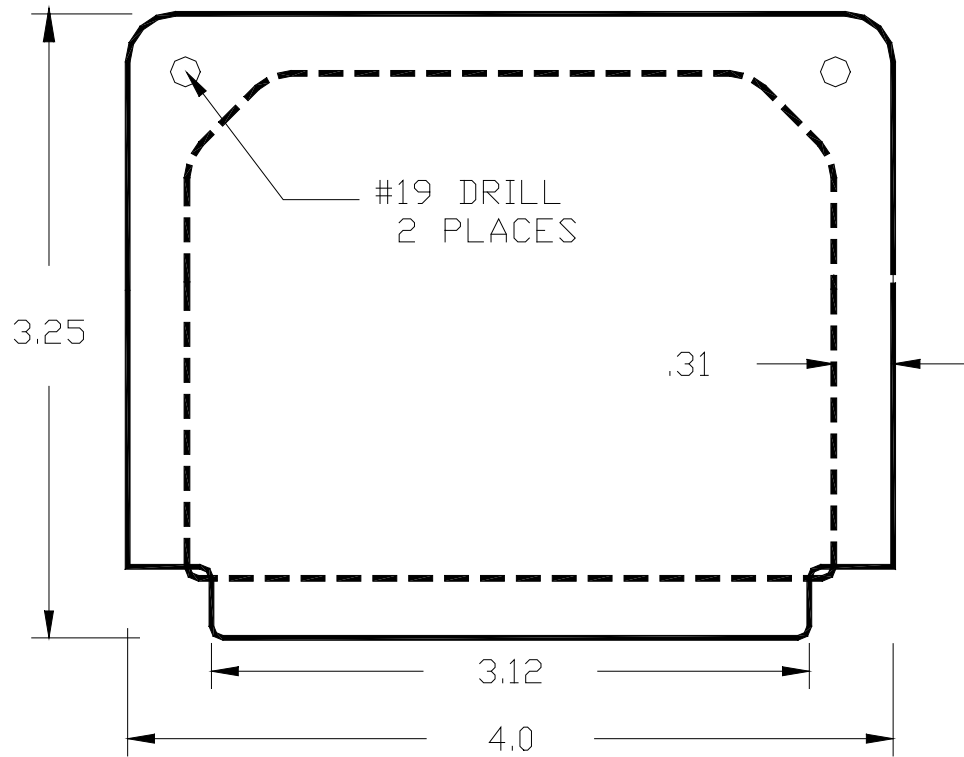
Figure 3. Small Inboard Cove Skin Cover Template

The flat pattern for the cover plates can be seen in Figures 3 and 4 below. The dashed line inside the perimeter is the profile of the access hole itself. (Do not cut this into the cover!) Use this template or cover when cutting the hole in the cove skin. Make sure you keep adequate edge margin for the two nut clips and number 8 screws that will hold the small cover down. The larger cover will use four screws and four nut clips each. The lower lip of the small cover is trimmed and joggled slightly to fit on the inside of the hole cut into the cove skin. The cove skins themselves are made from .016 thick aluminum skin. The covers could be made from .016, .020 or .025 aluminum. If you do not have any scrap material around to produce these covers yourself, a Service Bulletin Kit **P/N GSSB48KIT-2** can be purchased from Glasair Aviation USA, LLC. This kit includes sheet material for covers, screws and nut clips for four access panels.

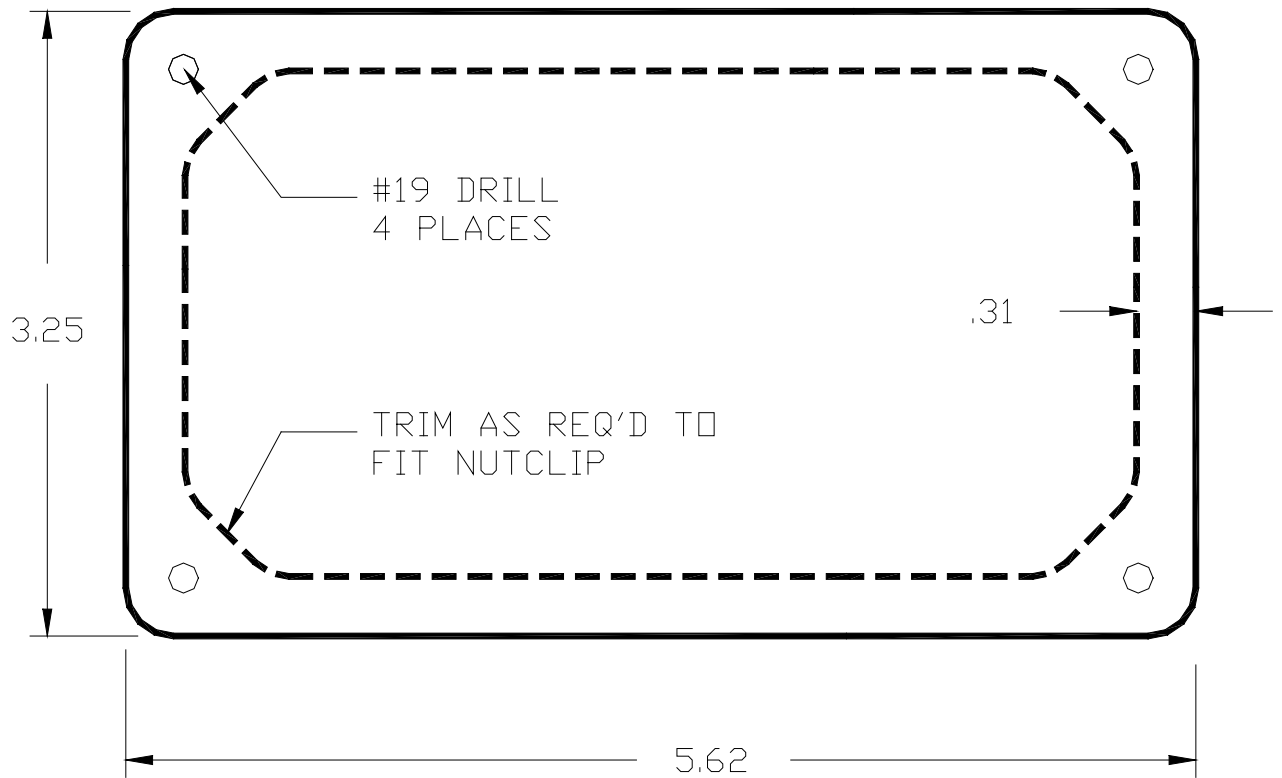
Figure 4. Large Outboard Cove Skin Template

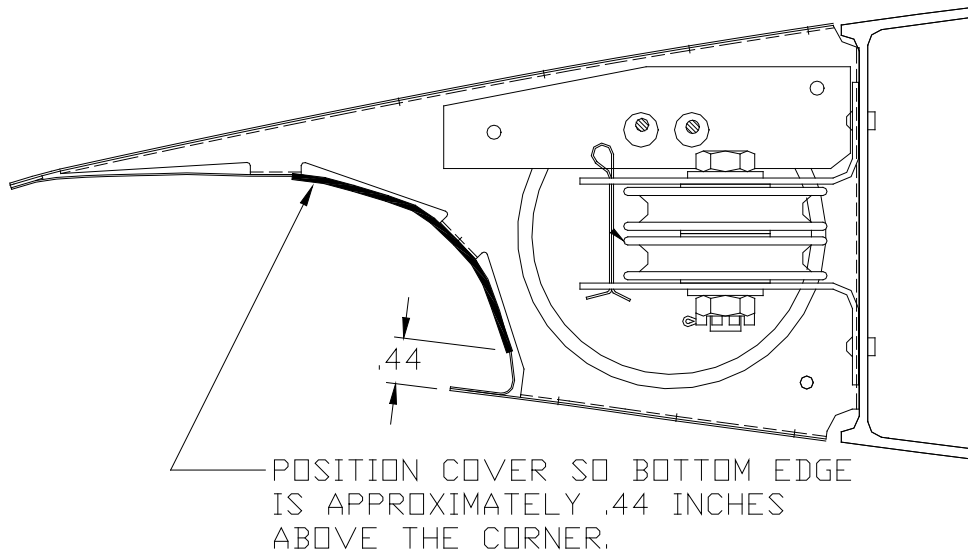
Figure 5. Position of Access Cover in Flap Cove Skin

When positioning the cover to the cove skin, place the bottom edge approximately .44 inches up from the corner as shown in Figure 5. Your corner fillet on the cove skin might vary slightly, so position the cover where **you** deem the best fit to access the pulleys or fairleads. Mark everything out with a felt tip marker first and make sure it will all work as planned. When you are ready to cut the actual access hole in the cove skin make sure you are only cutting the hole to the size shown by the dashed line on the cover template shown in Figure 3 and 4. Round the corners and position and or trim for the nut clips until the holes line up with the cover. (These are a 3/8 inch throat nut clip, so keep your edge margin 3/8 inch) The recommended position for the **outboard edge** of the outboard cover plate is one inch inboard of the flap/aileron cove transition or 109.50 inches from root of wing. The recommended position for the **outboard edge** of the smaller inboard cover plate is 44.5 inches outboard from the root of the wing. Deburr all sharp edges and clean up the aluminum shavings if you are working in a wing with the cove skins already installed.

Finally install the P/N 450-0211-081 Nut clips over the cove skin. Then secure each Cover Plate over the hole with AN526-8R6 Truss Head screws or equivalent ones of your choice.
