# ADVANCE NOTICE OF REVISION

(This Notice **supplements** all earlier Notices)

## ADVANCE NOTICE OF REVISION — 2/18/98

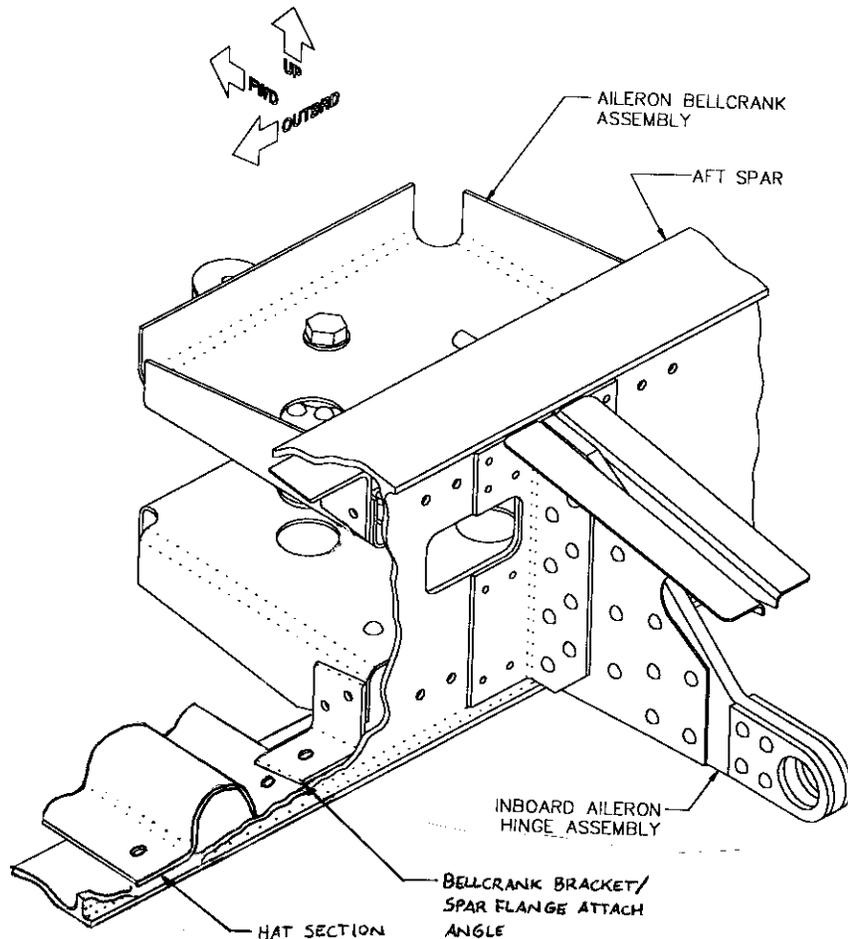
**Figure A: Placement of Hat Section Relative to Bellcrank Bracket/Spar Flange Attach Angle**

**Page 212:** A Note and illustration will be added to Step 66. The Note will explain and the illustration will show (see Figure A (right)) that the aft inboard corner of the flange of the hat section immediately outboard of the aileron bellcrank assembly must be tucked under the bellcrank bracket/spar flange attach angle. The hat section flanges are thin enough that this slightly unorthodox procedure poses no problem from either a construction or a structural standpoint.

**Page 155:** A Note will be added to Step 74 specifying that, as on the lower side, the aft inboard corner of the flange of the hat section immediately outboard of the aileron bellcrank assembly must be tucked "under" (above, relative to the aircraft) the bellcrank bracket/spar flange attach angle. A cross-reference back to Figure A (above) will be provided.

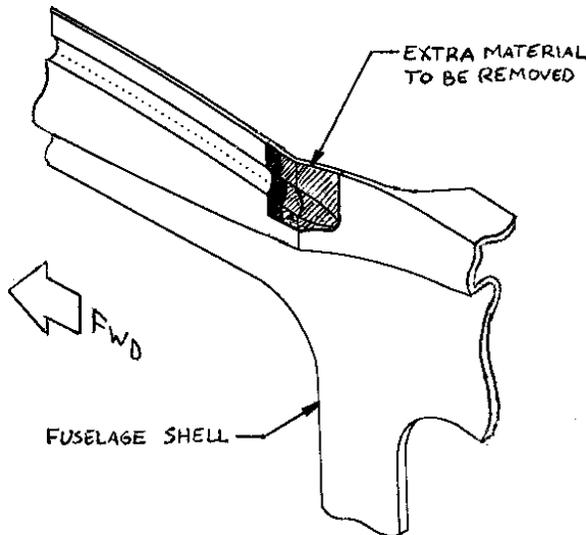
**Figure B: Cutting the Aileron and Flap Cable Clearance Slot**

**Pages 28–29:** The text of the second paragraph (including the Note) on Page 28 will be changed to call for cutting away more of the fiberglass fuselage shell than is currently specified. Specifically, the cutout for the **aft** lug of the alignment jig will be extended **aft to the end of the pre-molded depression in the shell** in order to accommodate the flap and aileron control cables. (Even more of the shell will be relieved later when the top-deck hatches are fitted.) Figure B (left) is a thumbnail view of the change that will be made to manual Figure 13 on Page 29.

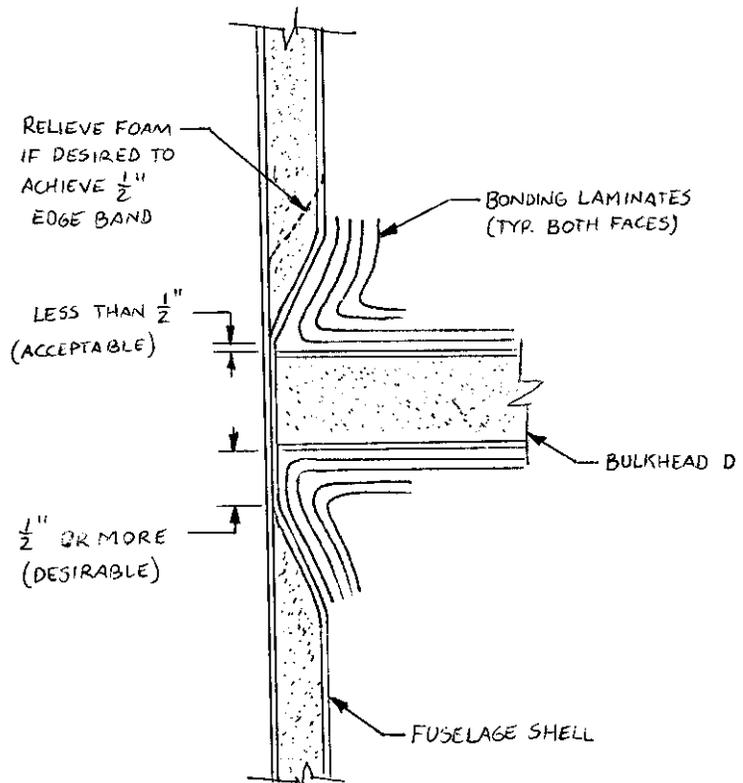
**Figure C: Bulkhead D Edge Band**

**Page 124:** A Note will be added to Step 68 discussing the positioning of Bulkhead D relative to the foam cutout in the fuselage shells. We have progressively refined the size and location of this cutout to better coincide with the placement of Bulkhead D. However, we are still receiving reports that the bulkhead, when positioned as instructed in Step 68 and Figure 87, rides up on the foam core portion of one or both fuselage shells. Ideally, the laminates used to bond Bulkhead D in place should have a so-called "edge band" of at least **1/2"**, as shown in Figure C (next page). If necessary, and if the builder so desires, he or she can relieve the foam core on one or both sides of the bulkhead to achieve this edge band. However, **this is not strictly necessary. In no event should the position of Bulkhead D be altered in order to achieve better alignment with the existing foam cutout.**

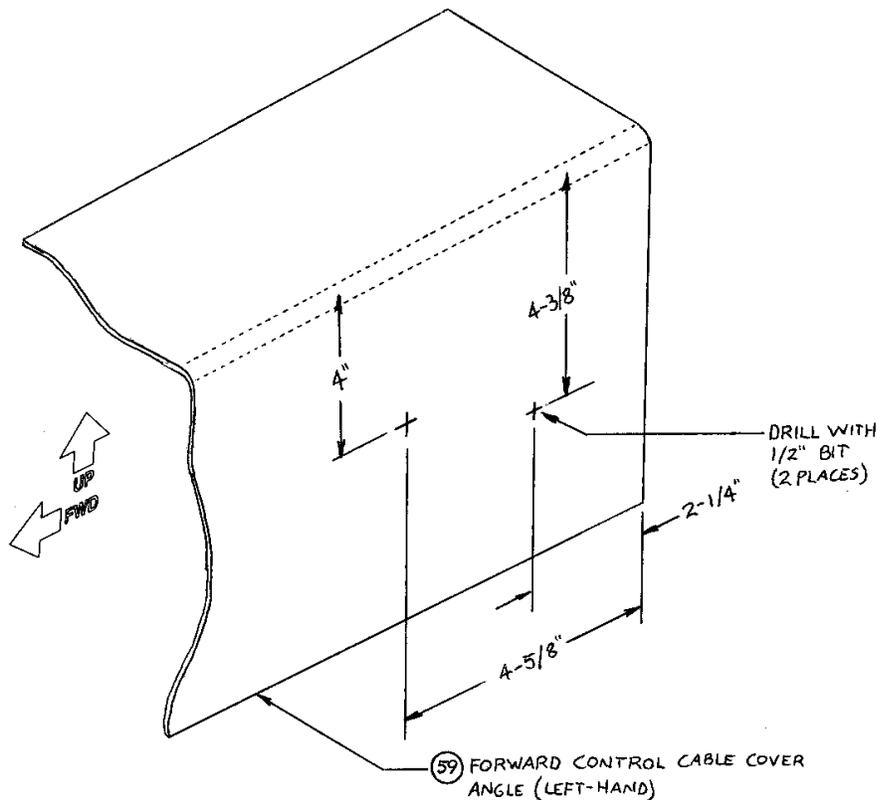
**Figure D: Additional Bolt Clearance Holes Required in Left-Hand Forward Control Cable Cover Half**

Additionally, text will be added to Step 15 and Figure 14 will be revised to show that two additional holes need to be drilled in the **left-hand** forward control cable cover half to accommodate bolt heads from two pulley groups inside the central truss. These bolt heads protrude left beyond the edge of the truss. Figure D (left) gives **approximate** dimensions for these holes. Double-check these locations before drilling 1/2" holes for these bolt heads.
