Glasair Service Bulletin 161

Subject: Inspection of RG Gear Oleos for Corrosion

Application: Glasair I and early model Glasair II RGs

Issue: Possible corrosion inside landing gear oleo struts

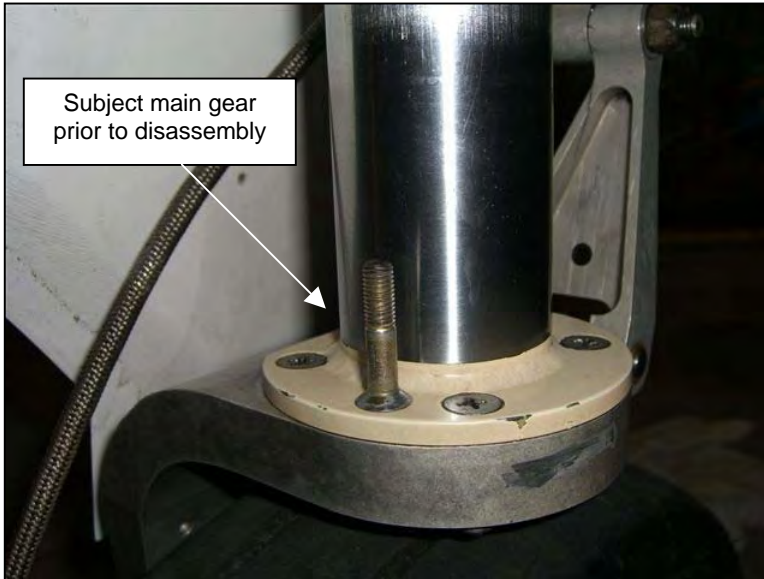
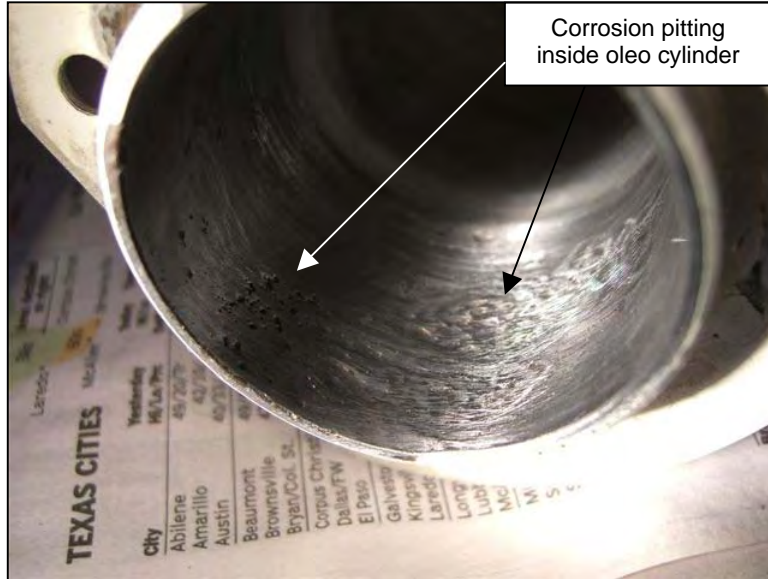
Due to landing gear exposure to moisture, water collected in one of the half fork pockets. Without a drain hole present in these half forks, over time the combination of moisture with dissimilar metals (aluminum plug and steel oleo) resulted in severe corrosion of the plug and inside diameter of the oleo. The corrosion moved up the inside diameter of the oleo tube to the level of the o-ring in the plug. The corrosion pattern was consistent with the gear down position (lower portion of the tube immersed in water) and the gear up position (lower surface of the tube wetted while it was horizontal).

Prior to reassembly of the half-fork having a machined pocket, drill a 3/16" diameter drain hole aligned with the center of the oleo strut so that moisture cannot get trapped inside.
